Date: October 23, 2006

Subject: Earthquake Emergency Response Visit at King Kamehameha I Birthplace
Big Island, Hawaii

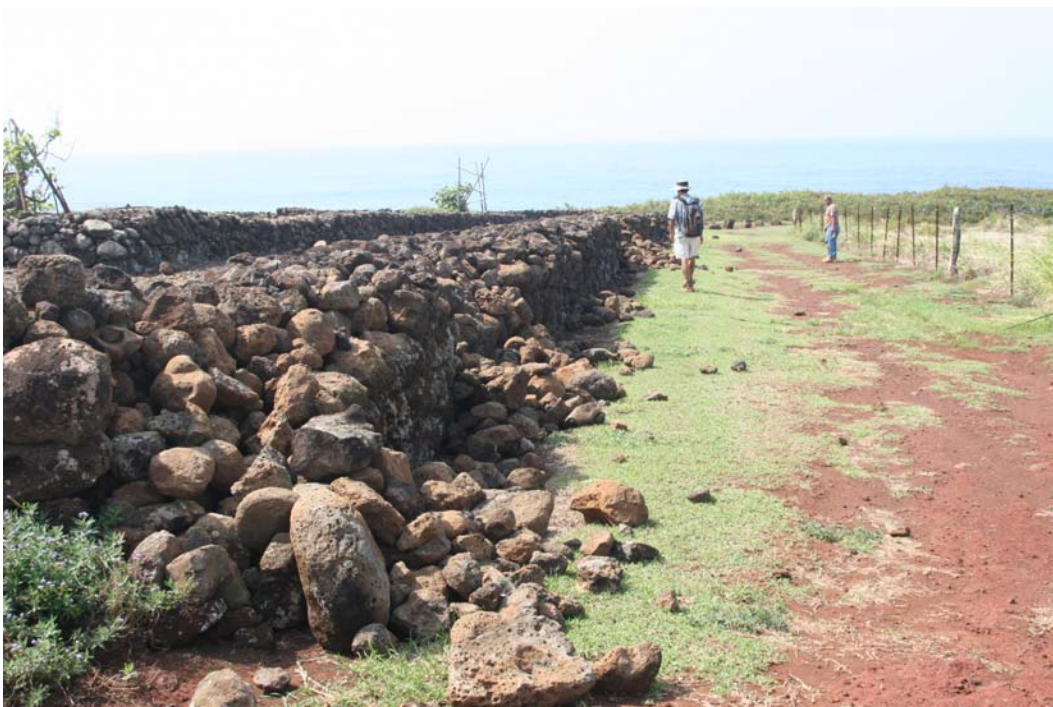
A walk through the site indicated that the both the perimeter and the inner rock walls have received sporadic damage at various points. Rocks were separated from the wall and were fallen on the nearby ground. The prevailing damage seemed to have occurred along the outer wall at a number of locations. See Photo No. 2 through 9. The damage to the inner structure was also recorded. See Photo No. 10 and 11.

Photo No. 2- Boulders dislodged from the wall structure.

The repair of this culturally sensitive structure requires a special type of methodology and approach which is different from conventional construction. It would take a particular master builder carefully chosen from among the Hawaiian community. We anticipate the cost of repair at approximately \$75,000 and a period of construction of 1 month.

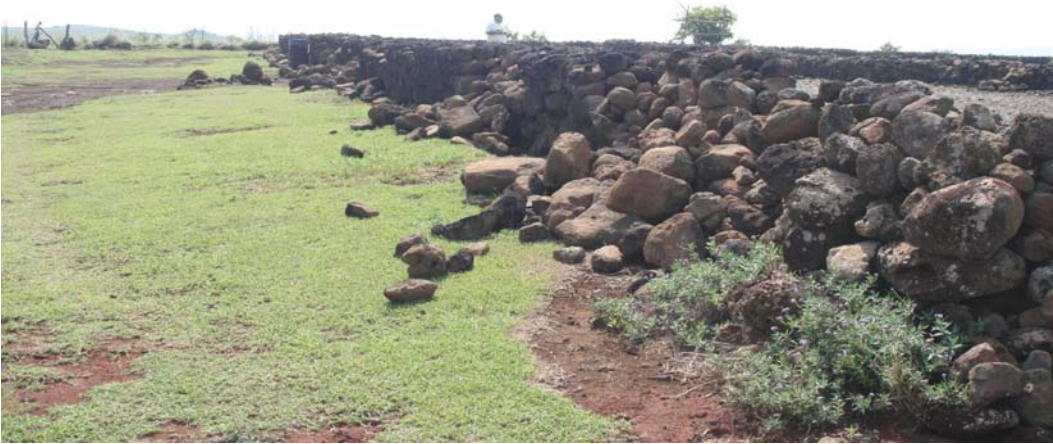
Photo No. 3- Outer wall failure due to ground motion.

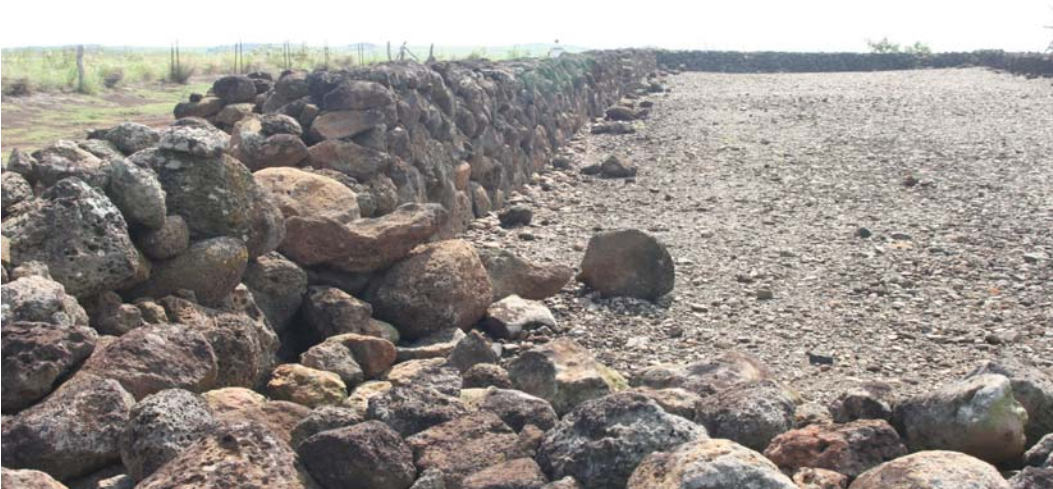
Photo No. 4- Wall failure along the inside of the perimeter wall.

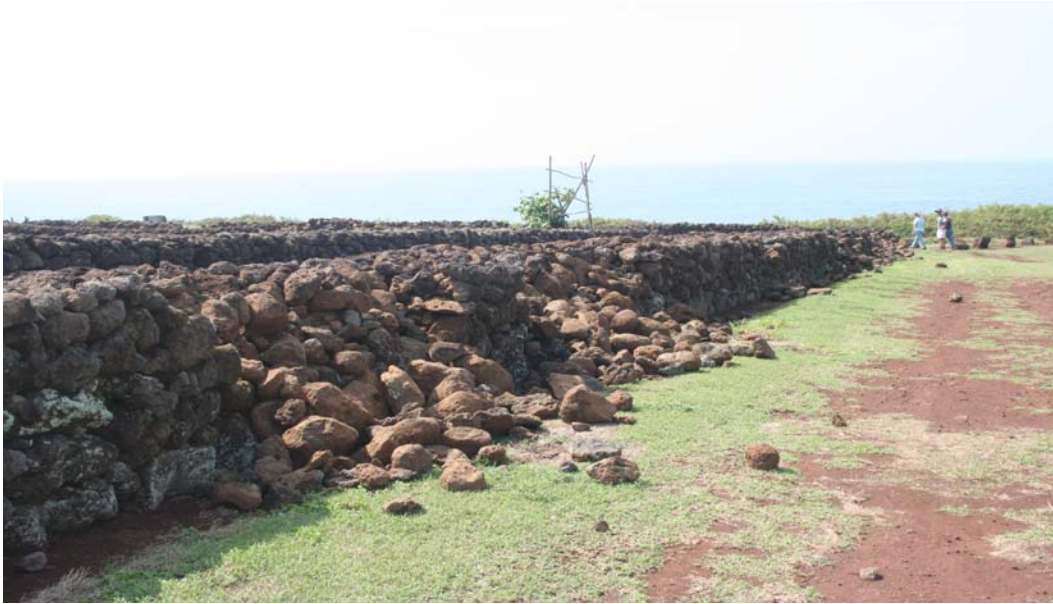
Photo No. 5- Mass failure of rock wall structure.

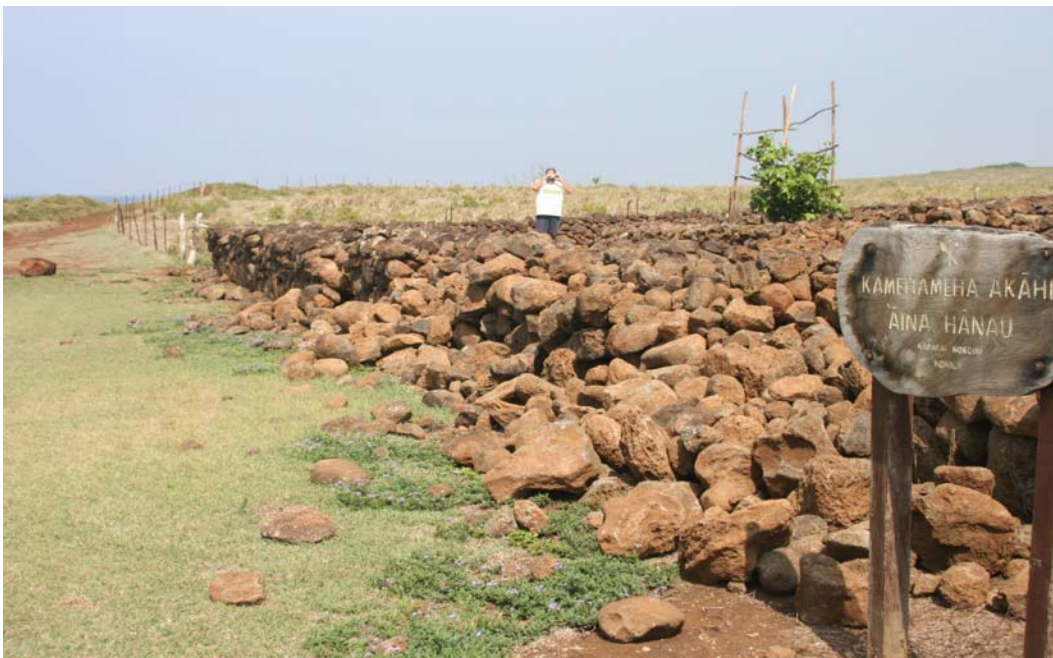
Photo No. 6- Scattering of the rocks from the wall due to earthquake.

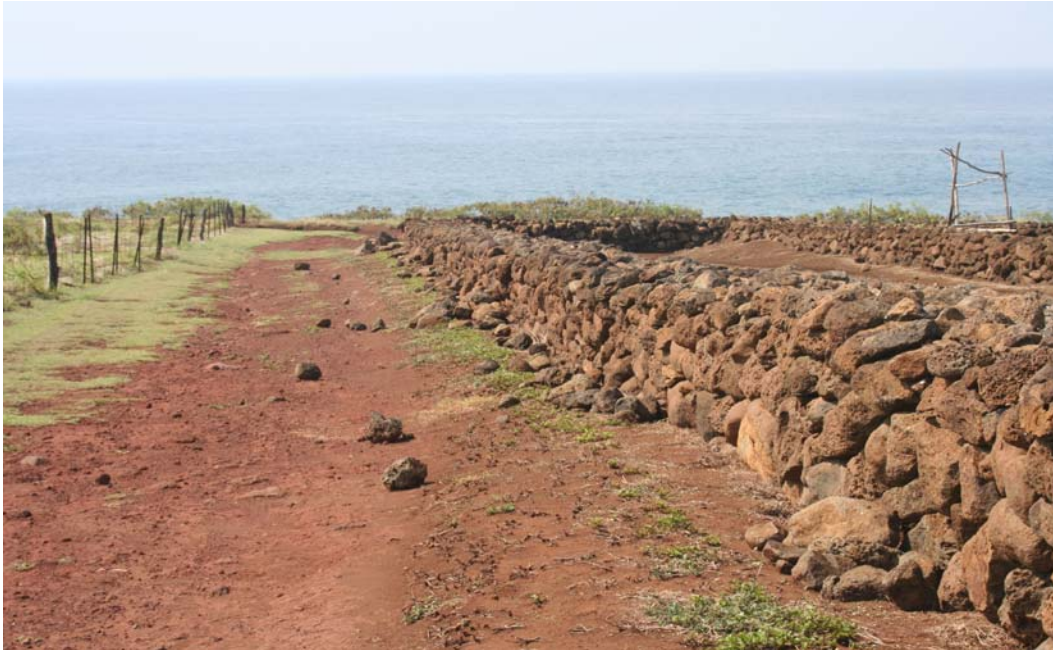
Photo No. 7- Fallen rocks from ground shaking.

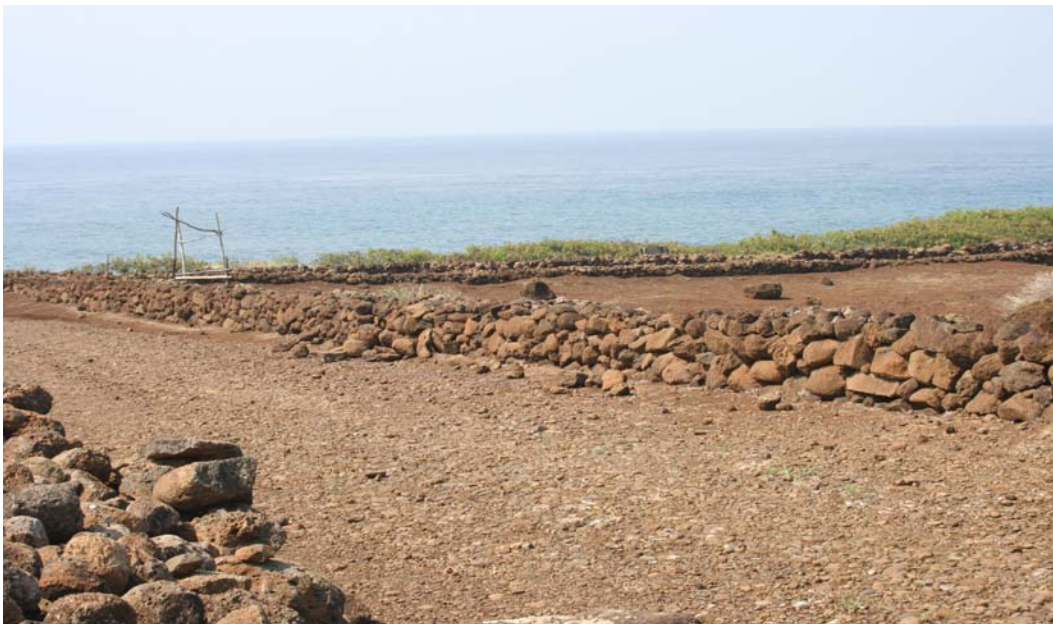
Photo No. 8- Scattered fallen boulders.

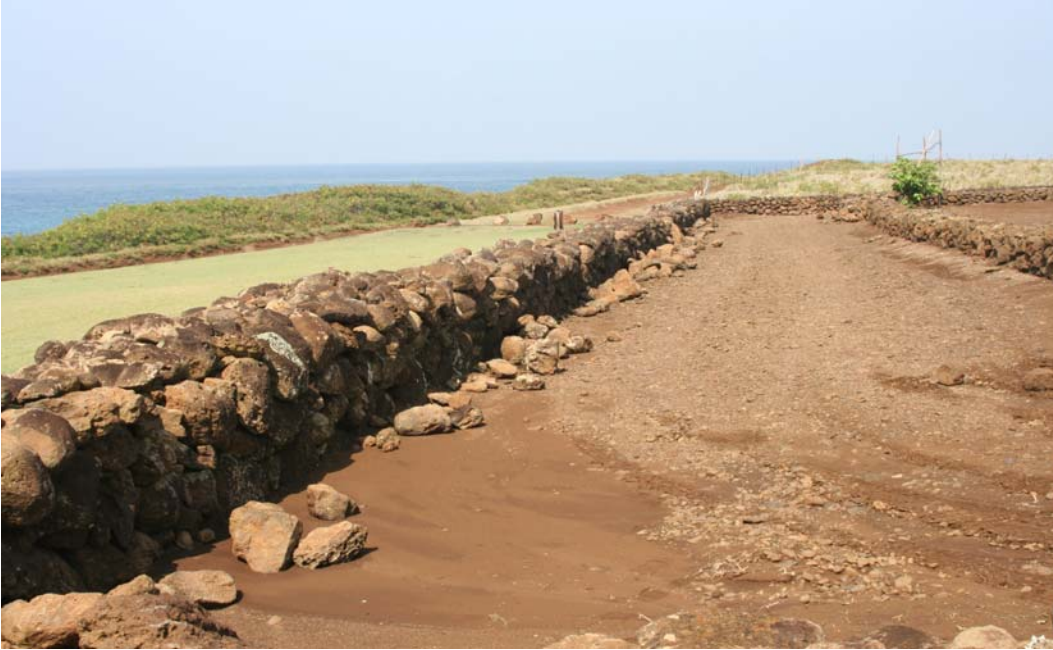
Photo No 9- Wall failure from ground motion.

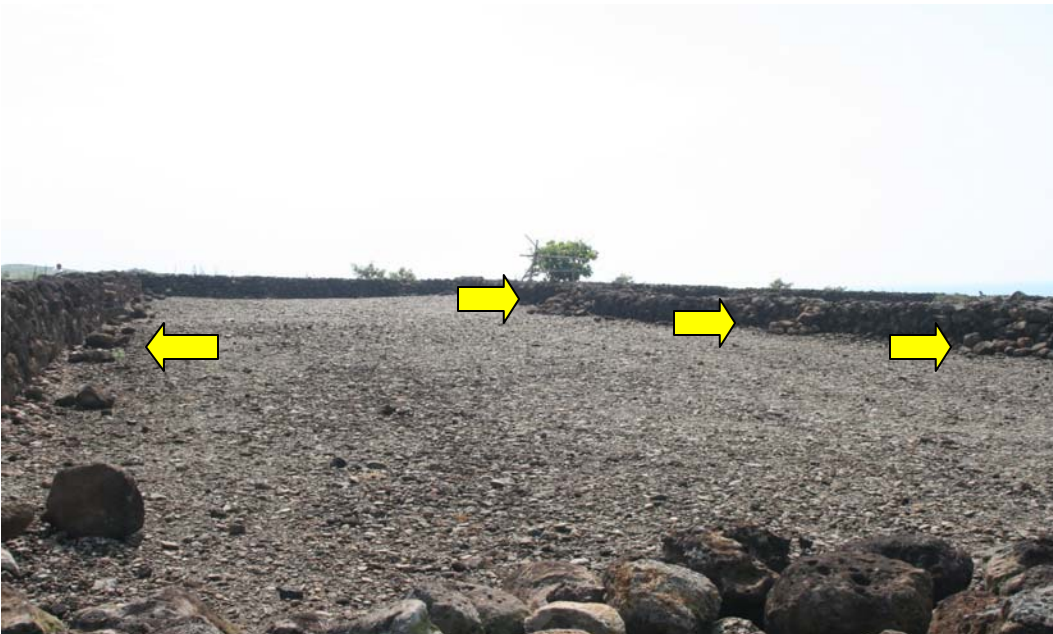
Photo No. 10- Wall failure along the inner and outer walls.

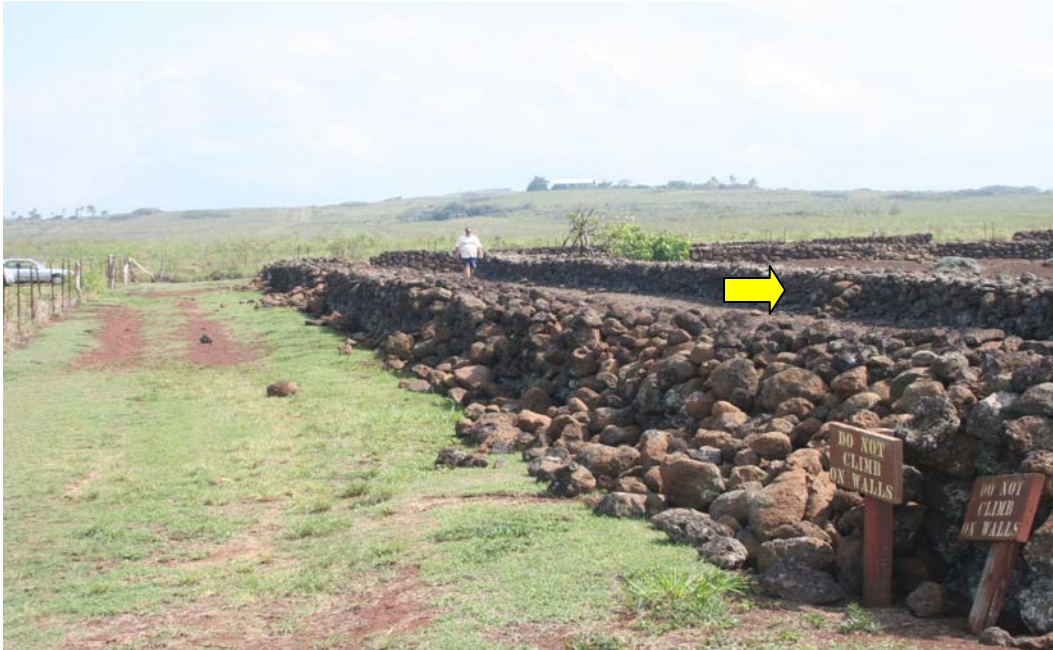
Photo No. 11- Loss of support caused rocks from both the inner and outer structures to fail.
